CPA Funding – FY2020 Final Application

Arlington Housing Authority
Building Envelope Repairs, Window Replacement, Phase 1
Winslow Towers 667-3, Elderly Housing
Schematic Report and Recommendations

Re: Winslow Towers Condition Assessment - DRAFT
WJE No. 2017.6855

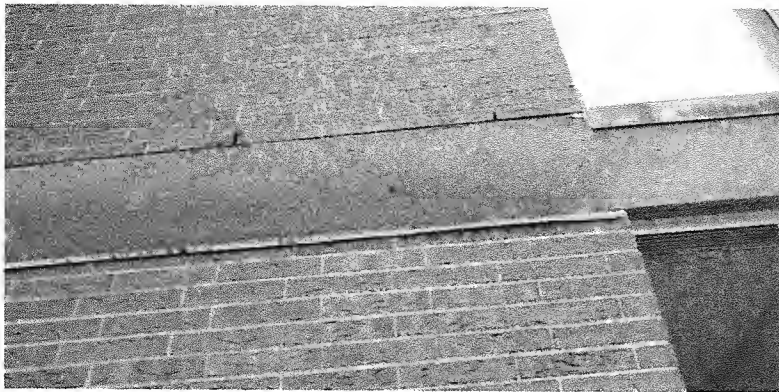
- Through wall flashings were observed at the floor line joint at the brick masonry bed joint as well as above the top course of brick at the joint below the perimeter beam soffit (Figure 5). Locations of observed flashing do not match original drawings, the flashing does not appear to have a drip edge, except at the bottom of the concrete beams, making it very difficult to locate accurately. Weeps were observed approximately every third brick at the floor line flashing.

Figure 5. Typical floor line perimeter beam with exposed flashing

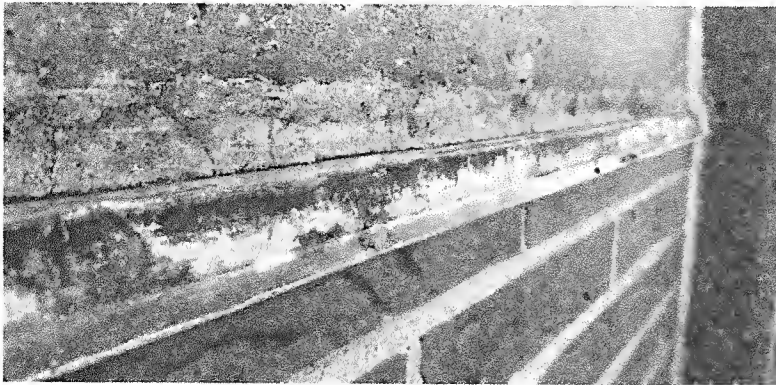
- Cracked mortar, bond line separation, and organic growth are typical at the mortar joint between the brick infill and the bottom of the exposed concrete beams (Figure 5).

Figure 6. Cracked mortar and organic growth at mortar joint between brick and concrete perimeter beam soffit

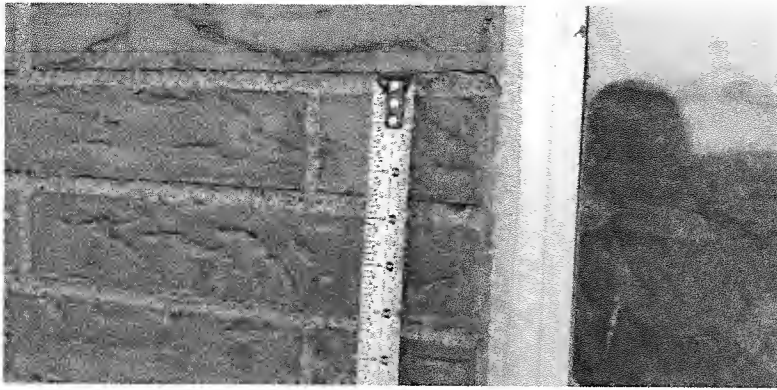
Figure 7. Typical mortar joint

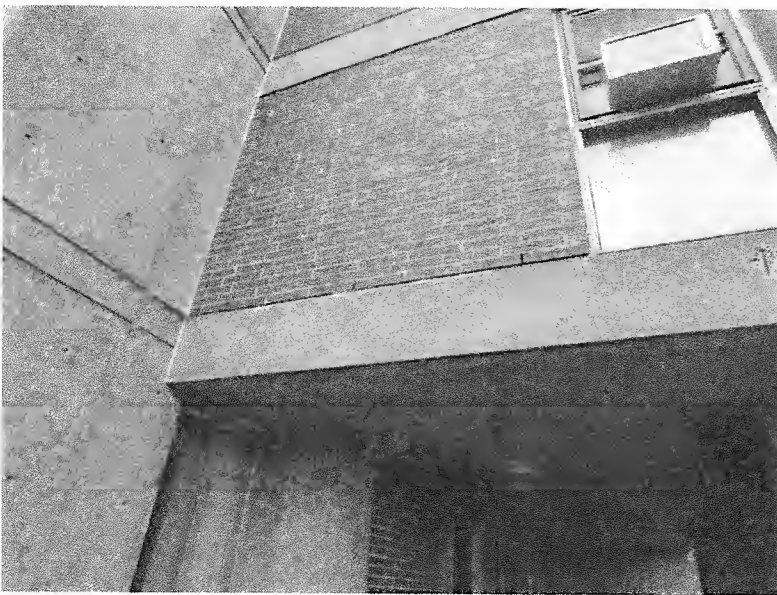
Figure 8. Sealant installed over mortar

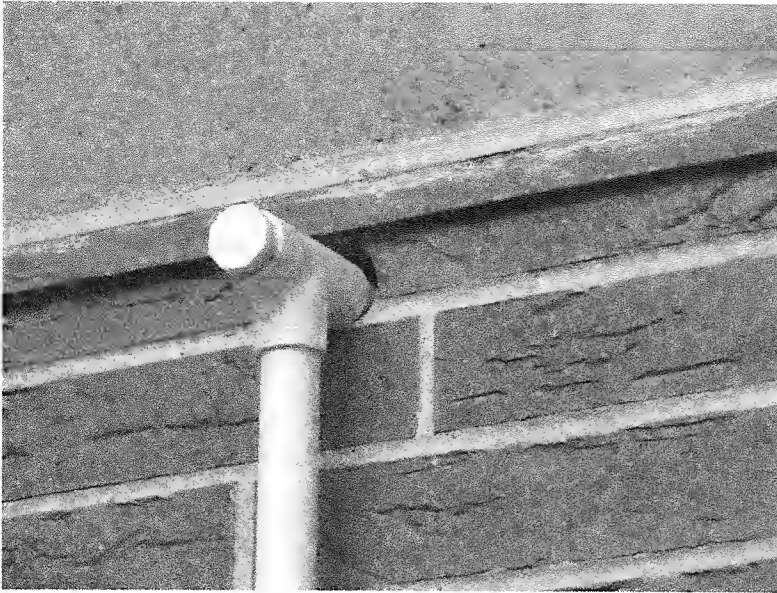
Figure 9. Unsealed PVC pipe penetration at the east facade, first floor

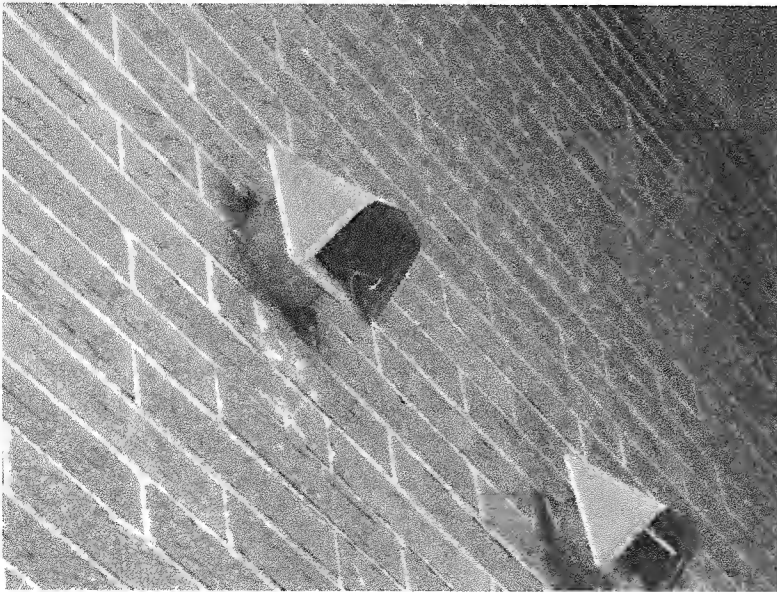
Figure 10. Bird's nest in unsealed vent

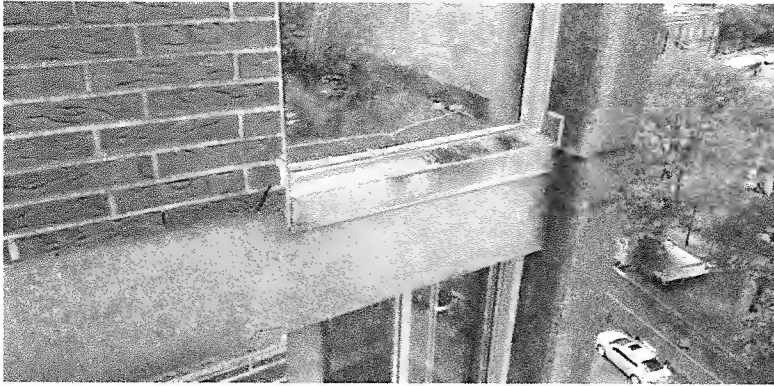
- One cracked brick was noted at the west facade adjacent to an eleventh-floor window (Figure 11).
- There are areas of organic growth and discoloration at the west facade (Figure 12).

Figure 11. Cracked brick at west facade, eleventh floor

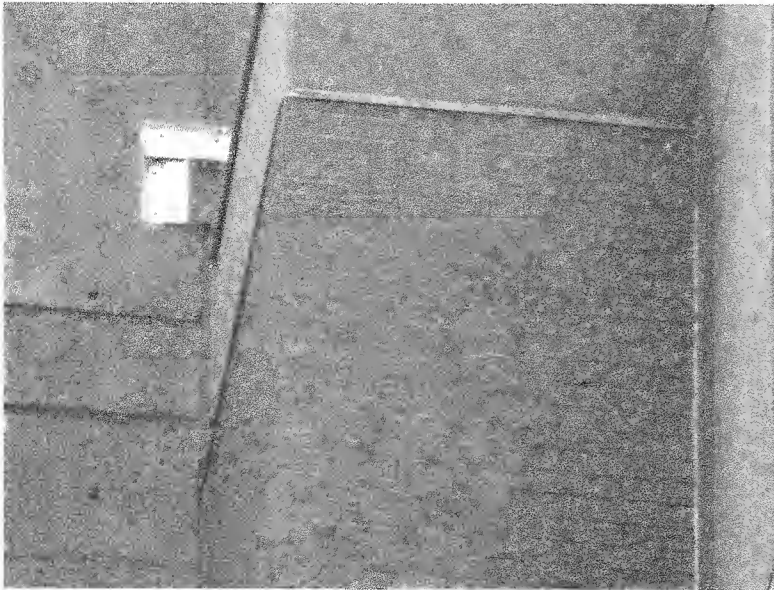
Figure 12. Organic growth and discoloration of brick at west facade

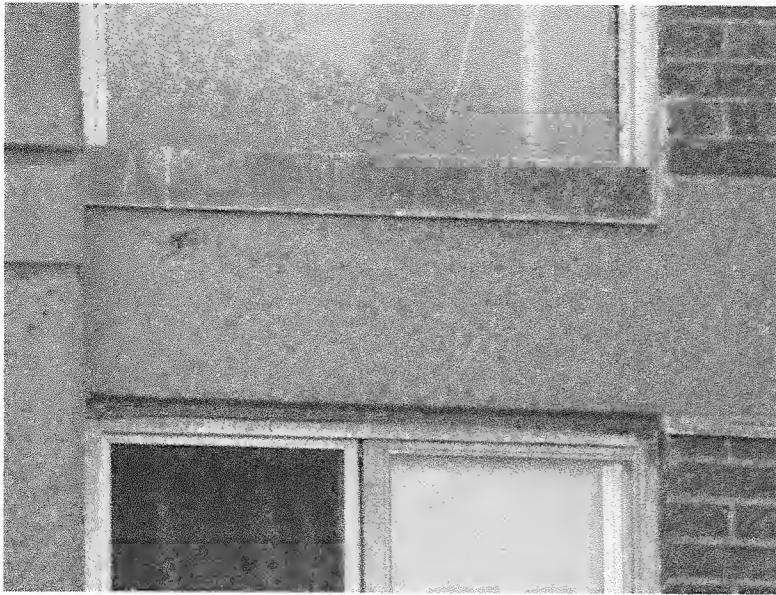
- There are multiple concrete spalls at perimeter beam at each facade (Figure 13). Shallow concrete cover (less than 1 inch), exposed, corroded reinforcing bars are typical at spall locations (Figure 14).
- One large spall (approximately 1 SF) was removed at the west facade during the close-up inspection (Figure 15).
- Incipient spalls are typical at perimeter beams, columns, and concrete shear walls at all facades (Figure 16 and Figure 17).
- Incipient spalls at all facades and concrete elements are most often observed at previous repair locations (Figure 18 and Figure 19). Previous repairs do not follow accepted industry practice for concrete repairs and have irregularly shaped perimeters and feather edging of the cementitious repair mortar.
- There is a 2 foot long vertical crack at the east facade (Figure 20)

Figure 13. Typical concrete spall at west facade perimeter beam

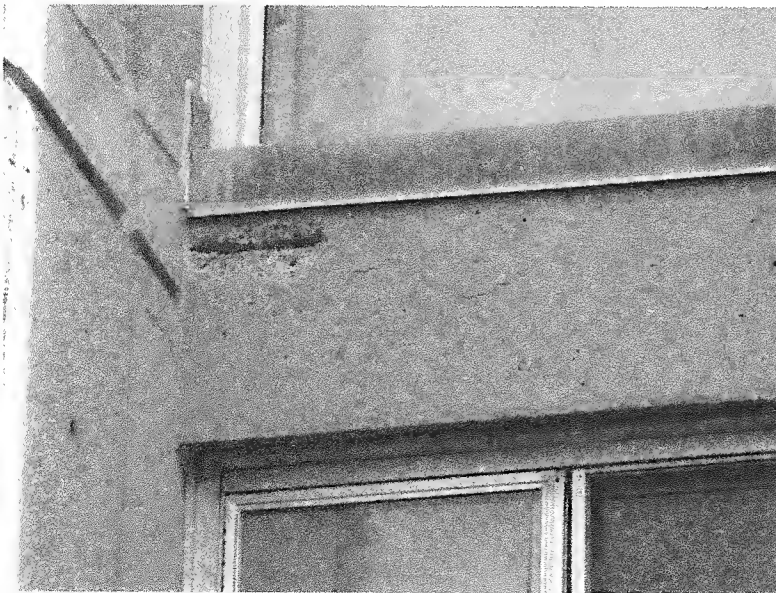
Figure 14. Exposed and reinforcing bar at concrete spall and adjacent delaminated concrete at south facade

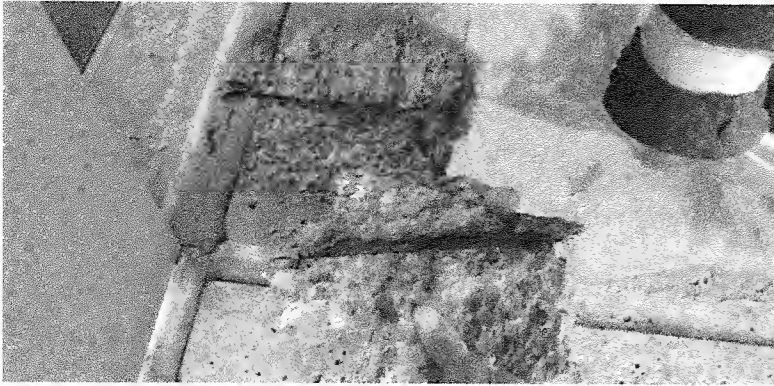
Figure 15. Large spall at west facade

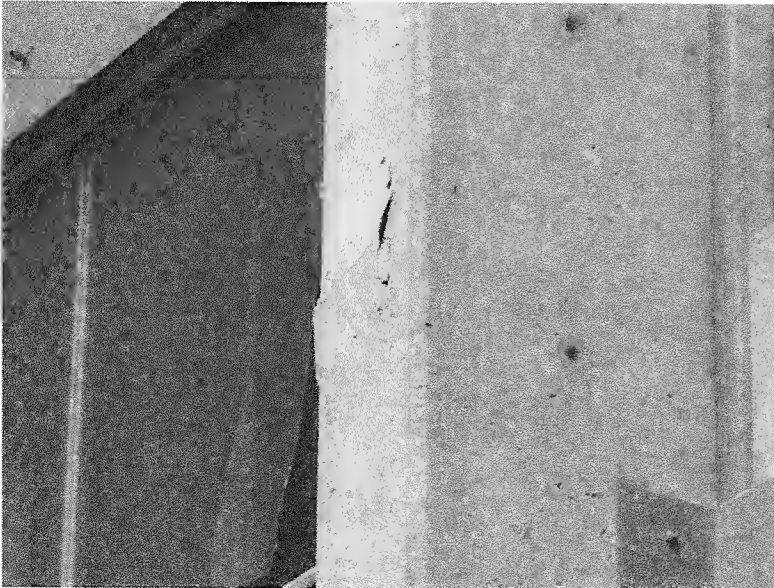
Figure 16. Incipient spall at concrete shear wall at south facade

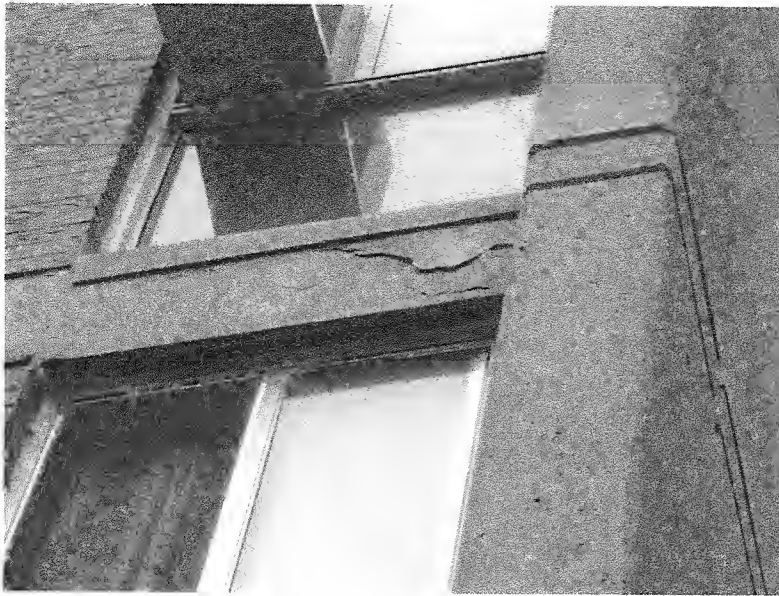
Figure 17. Incipient spall at concrete perimeter beam at east facade

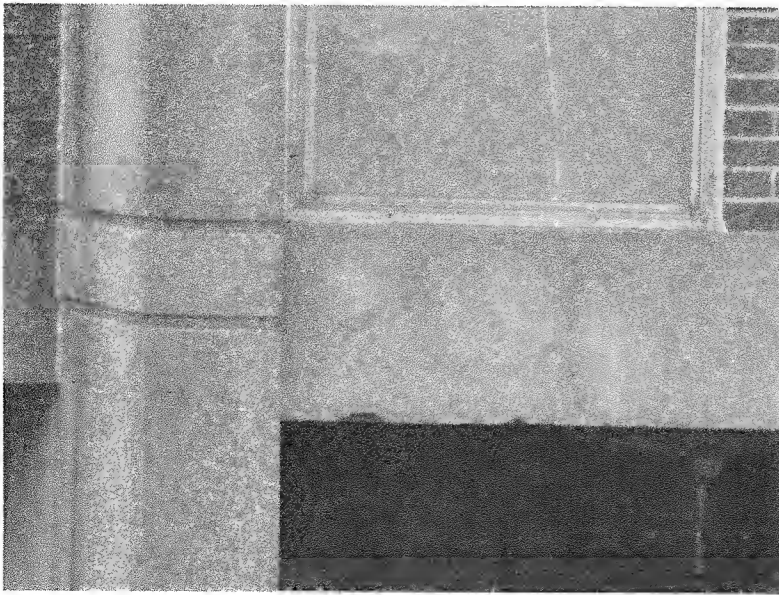
Figure 18. Incipient spall at repaired area at west facade

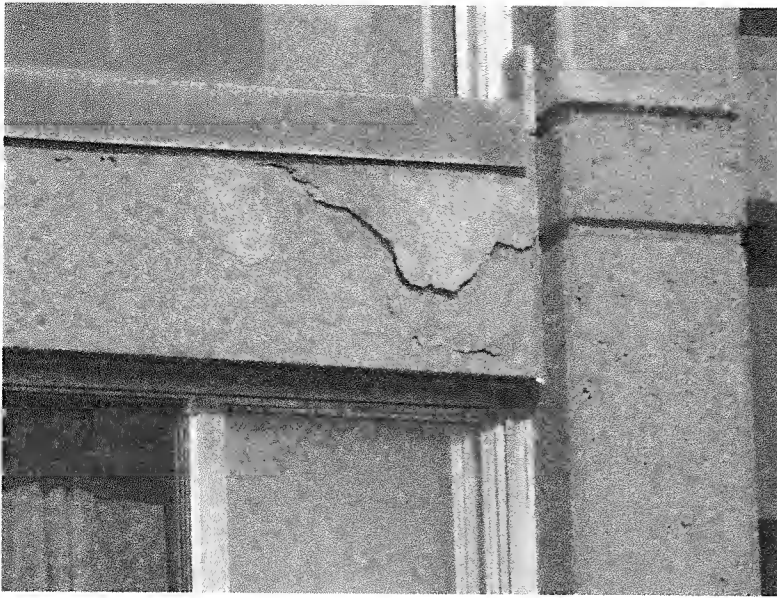
Figure 19. Incipient spall at repaired area at east facade

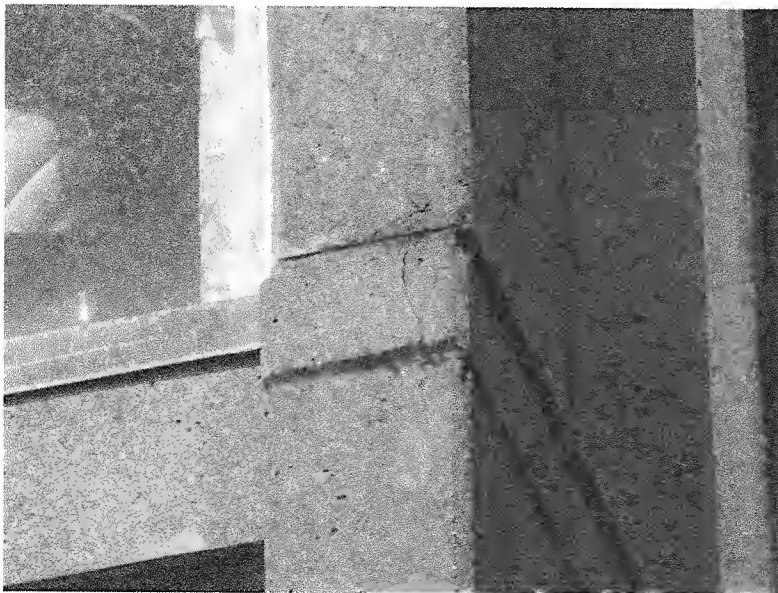
Figure 20. Large crack in concrete at east facade

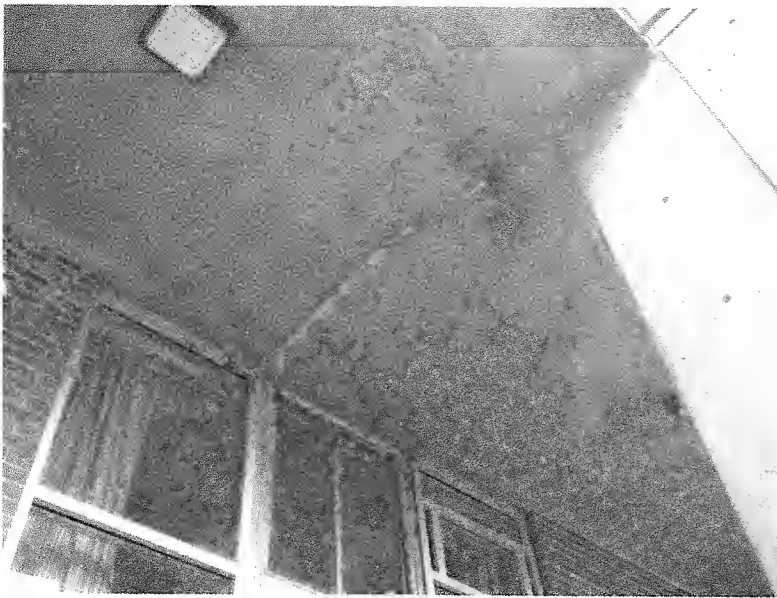
- There is a crack along the second floor soffit at the east facade. There is also efflorescence along the crack (Figure 21).
- There are several holes and unsealed penetrations at the facades, in particular at the first floor (Figure 22, Figure 23).
- At multiple locations, there are displaced pieces of wood that appear to have been used originally to form the drip edge above the window and were never removed (Figure 24).

Figure 21. Crack with efflorescence at east facade

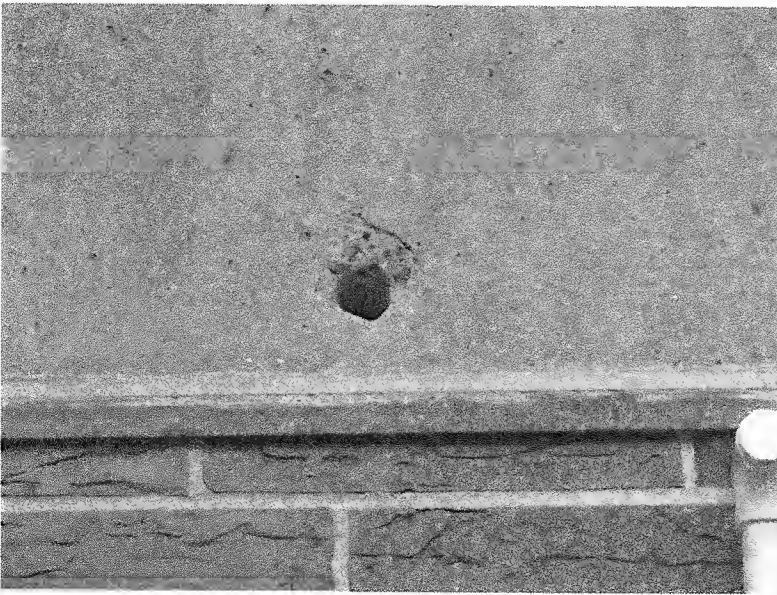
Figure 22. Unsealed hole at east facade, first floor

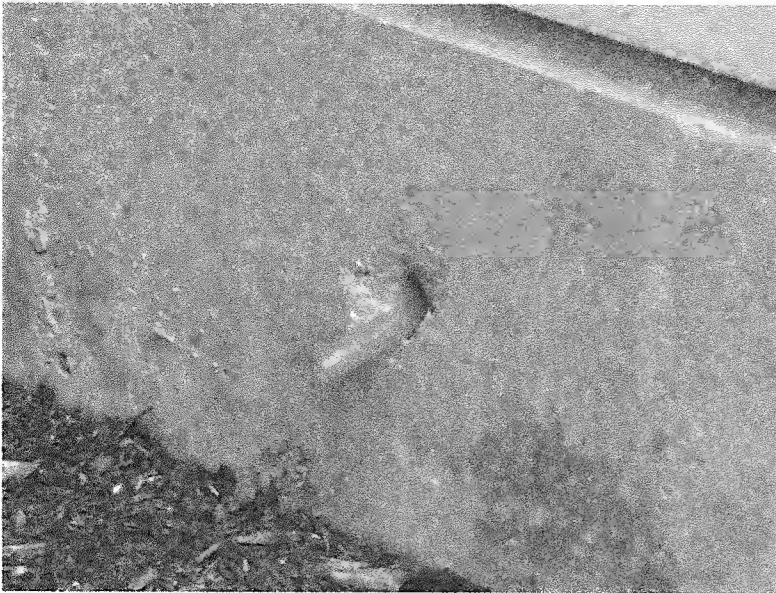
Figure 23. Unsealed penetration at east facade, first floor

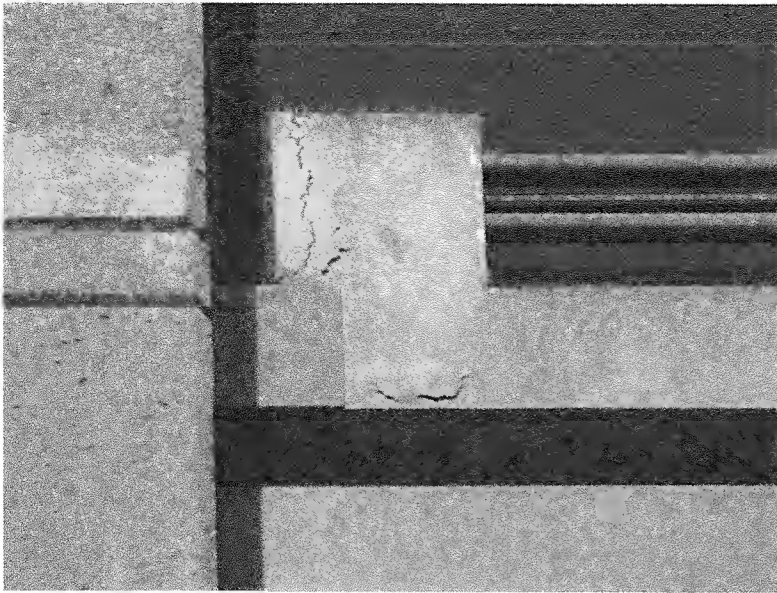
- There are multiple incipient spalls at the exterior of one tenth-floor precast concrete balcony rail (Figure 25).
- There is an incipient spall at the exterior of a third-floor balcony rail (Figure 26).
- There is a spall at the bottom of one tenth-floor balcony rail (Figure 27).
- Concrete cracking was noted at the interiors of balcony rails at three Units surveyed. Cracking, where observed, was typically adjacent to embedded anchor locations (Figure 28)
- Organic growth is typical at the face of precast concrete balcony rails at the north, east, and west facades (Figure 29).
- Dirt and staining was observed at many of the balcony decks adjacent to drains at the edge of the balcony (Figure 30).

Figure 25. Incipient spalls on concrete balcony rail at east facade, tenth floor

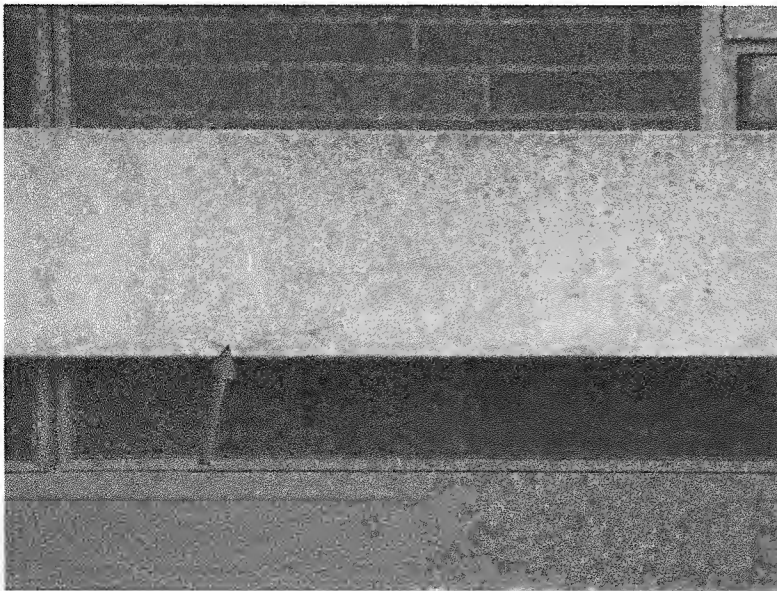
Figure 26. Incipient spall on balcony rail at west facade, third floor

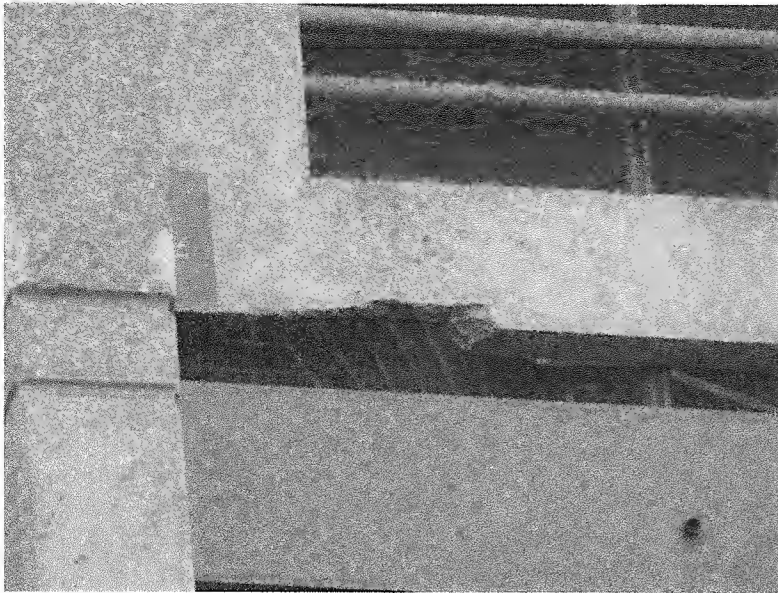
Figure 27. Spall at bottom of concrete balcony rail at south facade, tenth floor

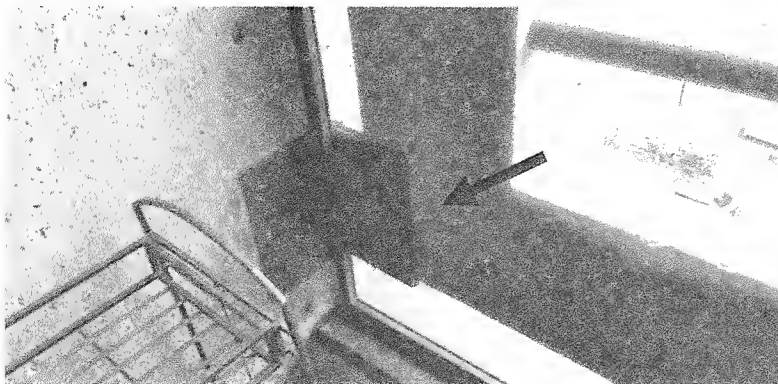
Figure 28. Concrete cracking next to anchor at balcony rail interior

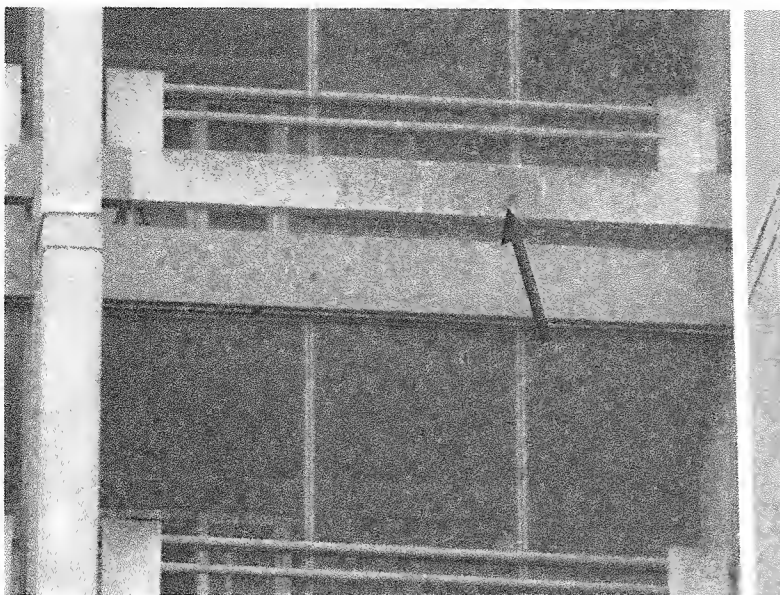
Figure 29. Organic growth on precast concrete balcony rails at west facade

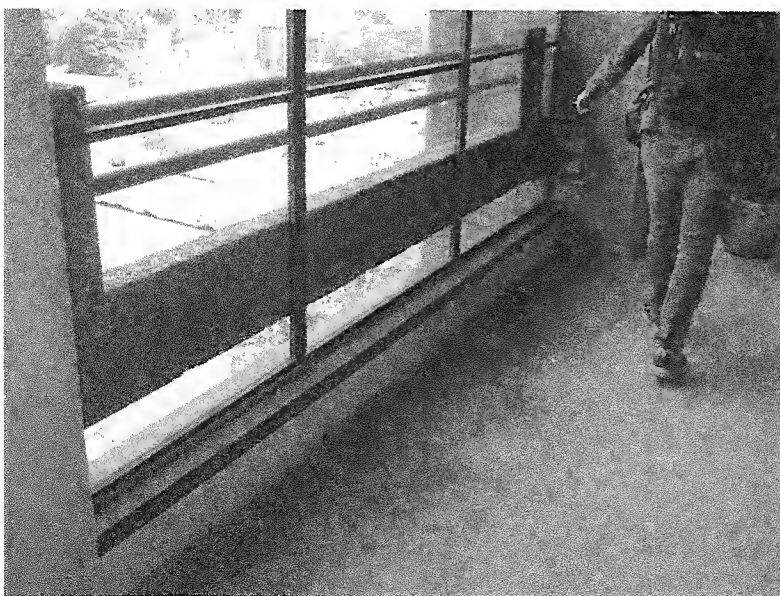
Figure 30. Typical dirt at balcony adjacent to drains

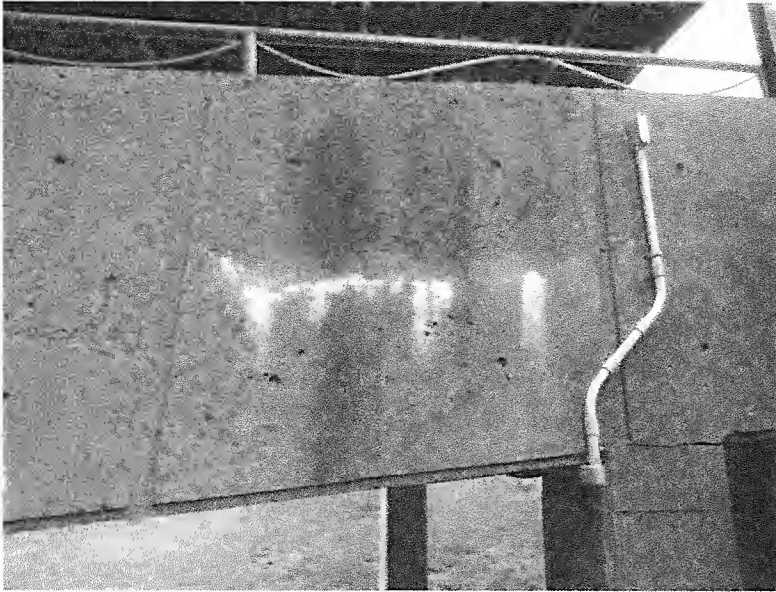
- There are concrete cracks with efflorescence along the west side of the bridge (Figure 31).
- Cracks with efflorescence and corrosion staining are typical at the underside of the bridge (Figure 32 and Figure 33).
- There are incipient spalls at multiple locations at the bridge soffit (Figure 34).
- A large crystalline deposit has developed at an electrical penetration location (Figure 35).
- One of the drain pipes under the bridge is fractured (Figure 36).

Figure 31. Cracks in concrete with efflorescence at west side of pedestrian bridge

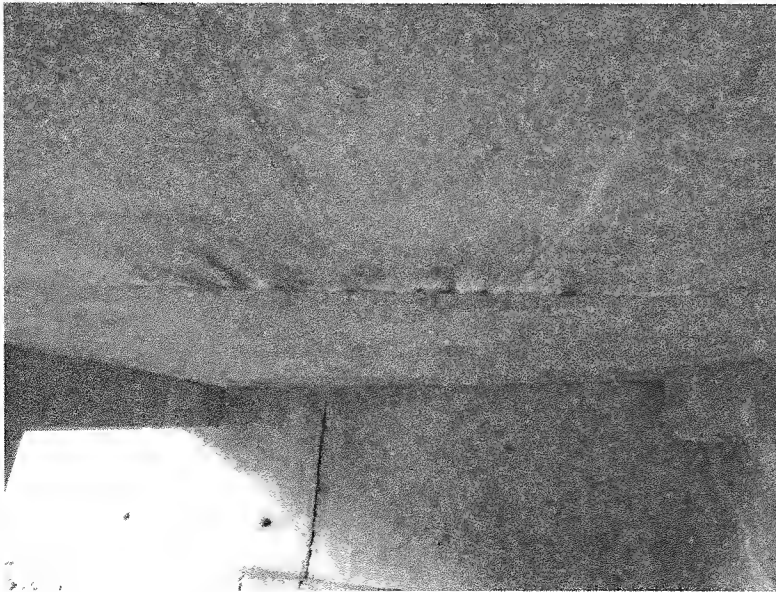
Figure 32. Cracks in concrete with efflorescence and corrosion staining at underside of pedestrian bridge

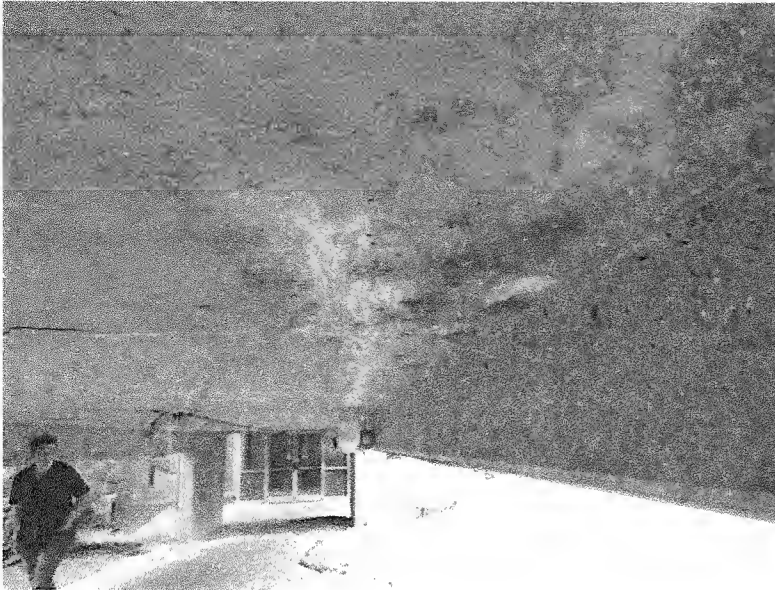
Figure 33. Cracks in concrete with efflorescence and corrosion staining at underside of pedestrian bridge

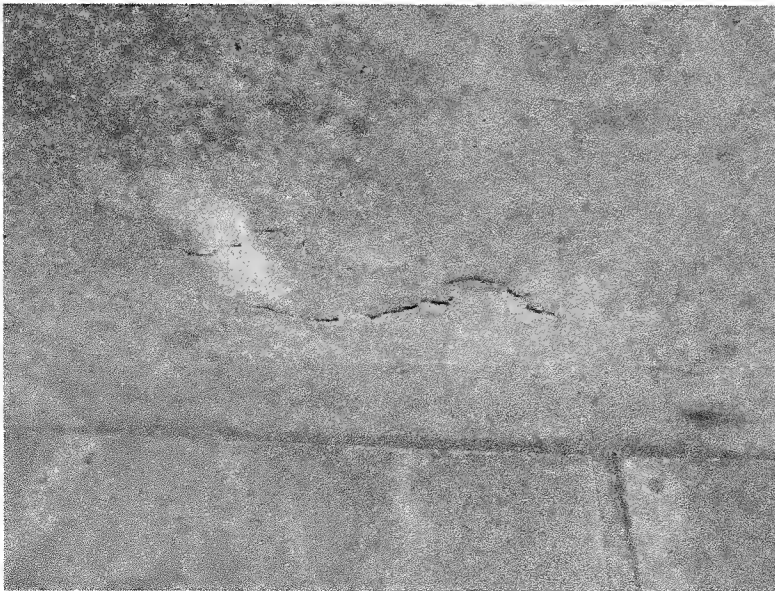
Figure 34. Incipient spalls in concrete at underside of pedestrian bridge

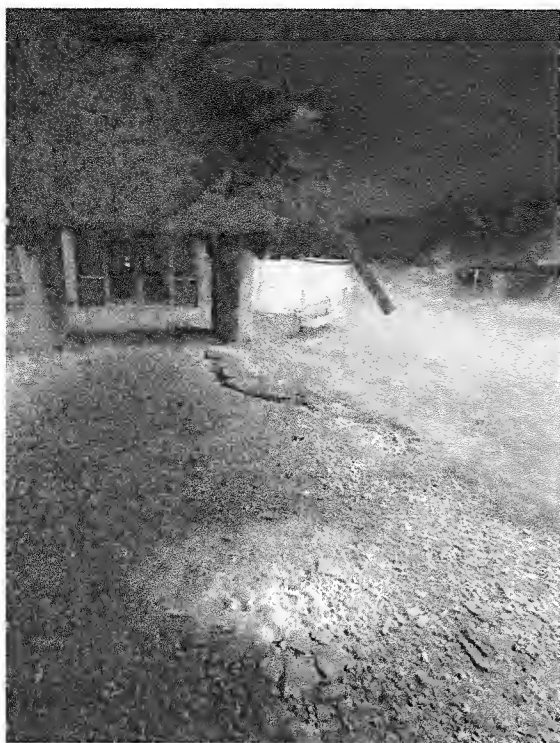
Figure 35. Efflorescence at penetration at underside of pedestrian bridge

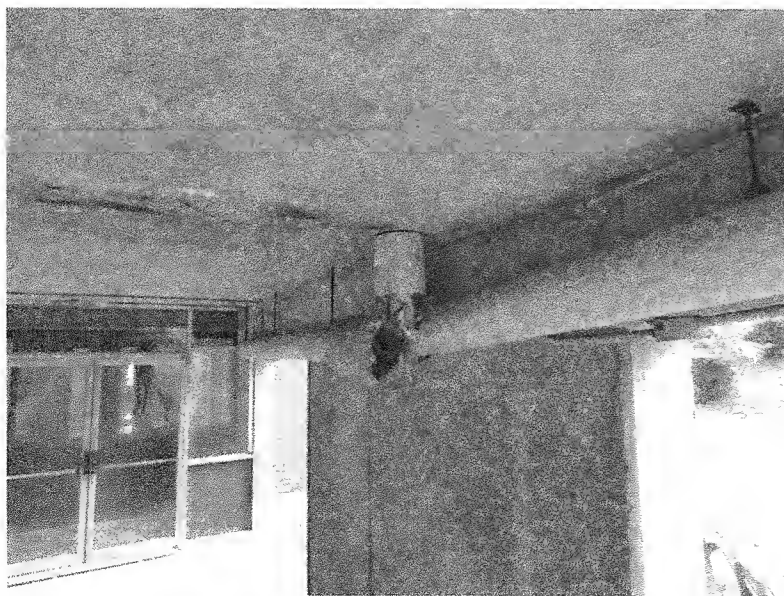
Figure 36. Broken pipe drain at underside of pedestrian bridge

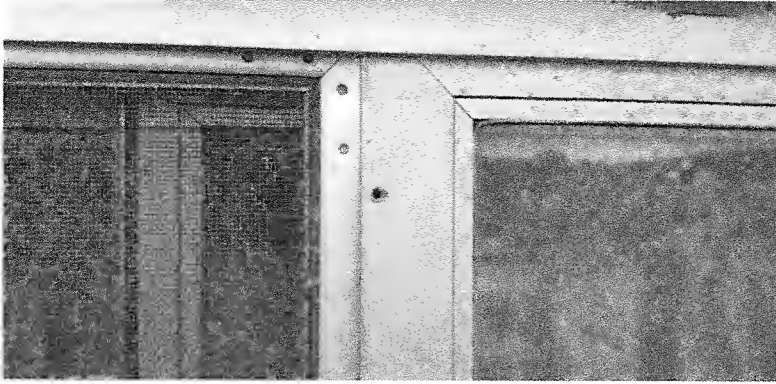
- Holes and missing fasteners are typical at window framing (Figure 37).
- Surface corrosion was observed of two frames at the first-floor north facade windows (Figure 38 and Figure 39).
- Glass is cracked glass at two of the first-floor windows (Figure 40).

Figure 37. Fasteners missing from window framing

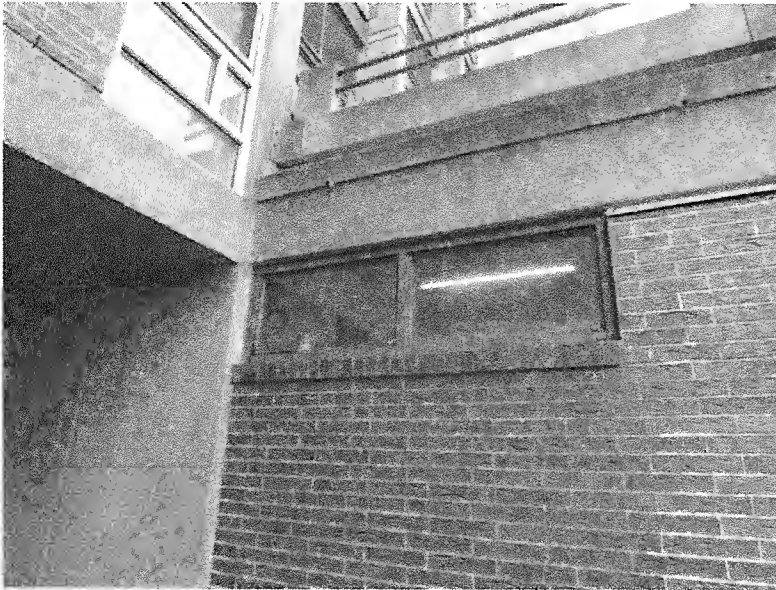
Figure 38. Corroded window frame at north facade, first floor

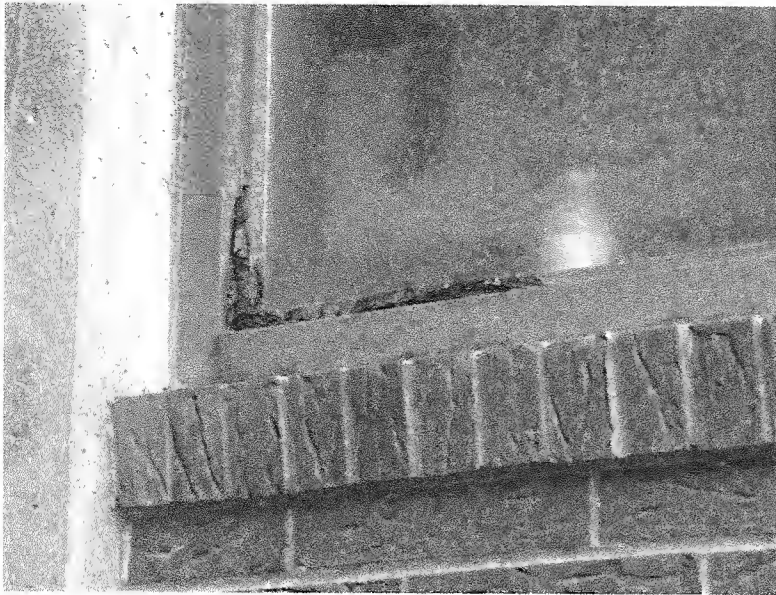
Figure 39. Corroded window frame at north facade, first floor

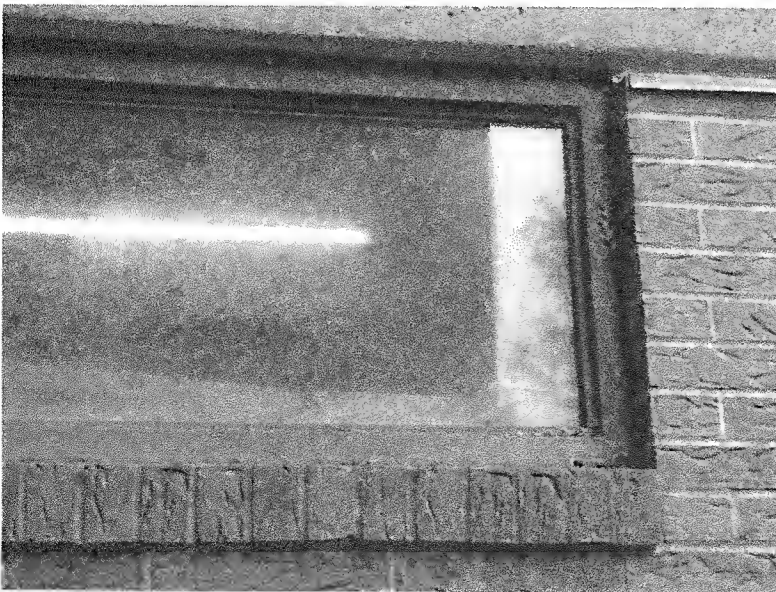
Figure 40. Cracked glass in window with corroded frame at north facade, first floor

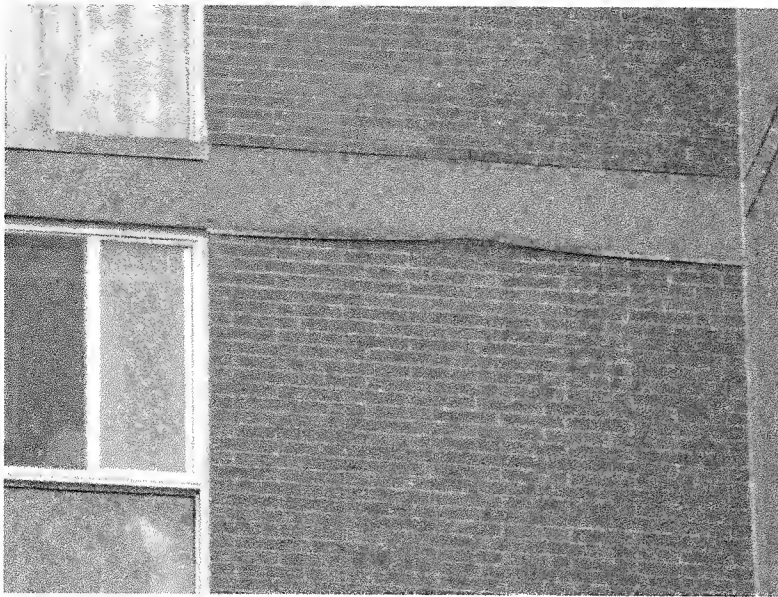
- Bent (approximately 10 feet) and displaced top of wall (concrete perimeter beam soffit) flashing at the eleventh-floor of the west facade (Figure 41).
- Window sill flashing includes upturned legs at the jambs. The upturned ends of the flashing are typically not regletted into the concrete at the column or mortar joint at the infill masonry wall, instead they are face-sealed to the substrate (Figure 42). In some locations, the mortar joints were cut but the upturned leg of the flashing is too short to be installed into the reglet (Figure 43).
- Displaced sill flashing was noted at one location at the west facade (Figure 44 and Figure 45).

Figure 41. Bent and displaced top of wall flashing at west facade, eleventh floor

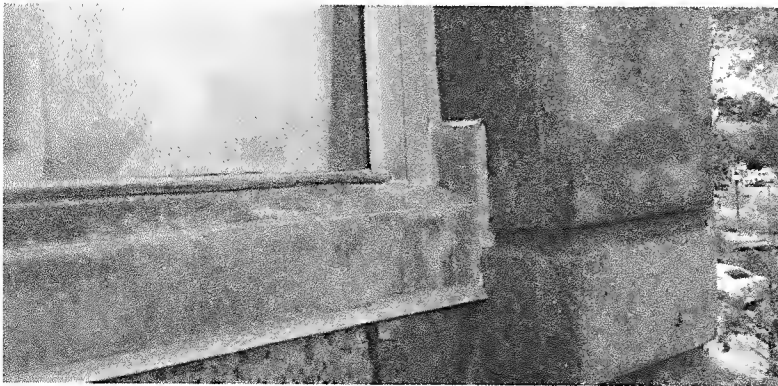
Figure 42. Upturned leg of window sill flashing face-sealed to substrate and not recessed into a reglet

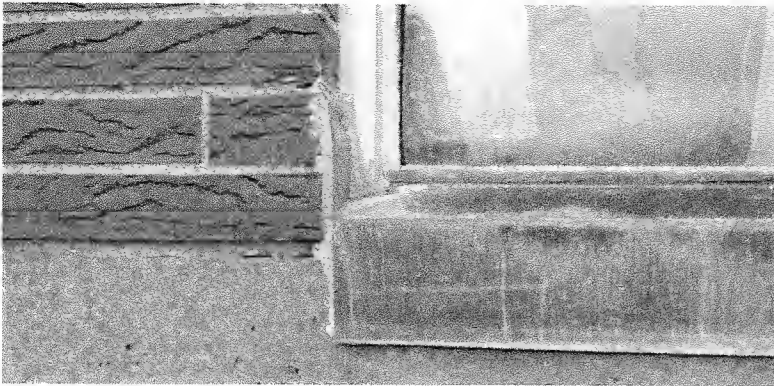
Figure 43. Cut mortar joint without embedded flashing

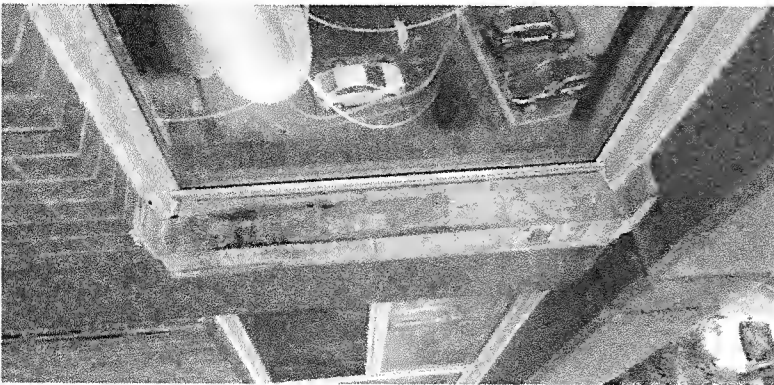
Figure 44. Sill flashing displaced at west facade

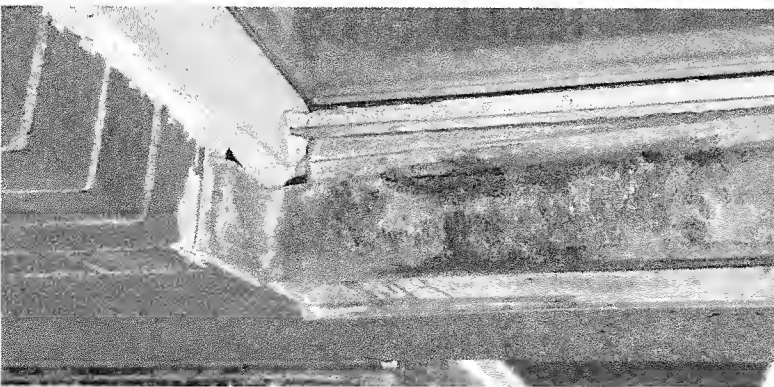
Figure 45. Sill flashing displaced at west facade

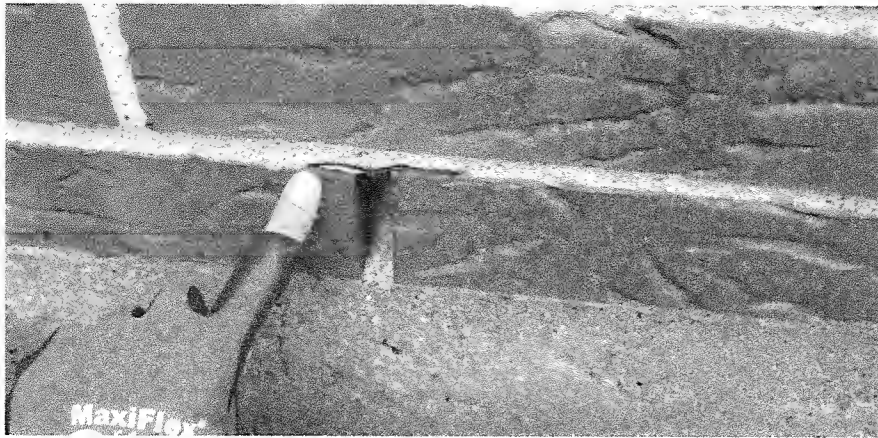
- An unidentified material, potentially flashing material or an exposed brick tie, was noted one course above floor line, above a weep (Figure 46).

Figure 46. Exposed material above weep hole in first course of brick above concrete floor line

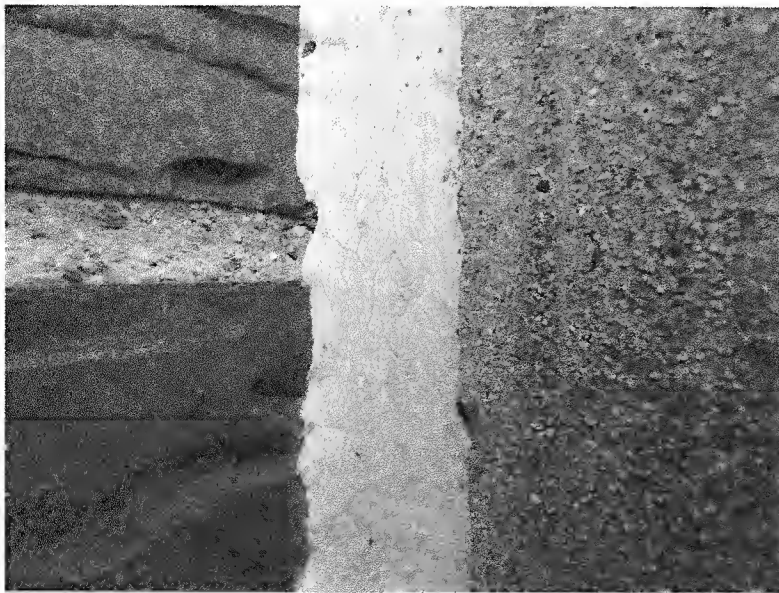
- Sealant is typically crazed, hard, and brittle (Figure 47).
- There is a missing sealant joint between the head and the underside of the lintel at one door perimeter at the north facade (Figure 48).
- Window perimeter sealant is typically failed cohesively and/or adhesively (Figure 49 and Figure 50).
- Layers of sealant were noted in many locations (Figure 51).

Figure 47. Crazed, hard, and brittle sealant in corner joint at west facade

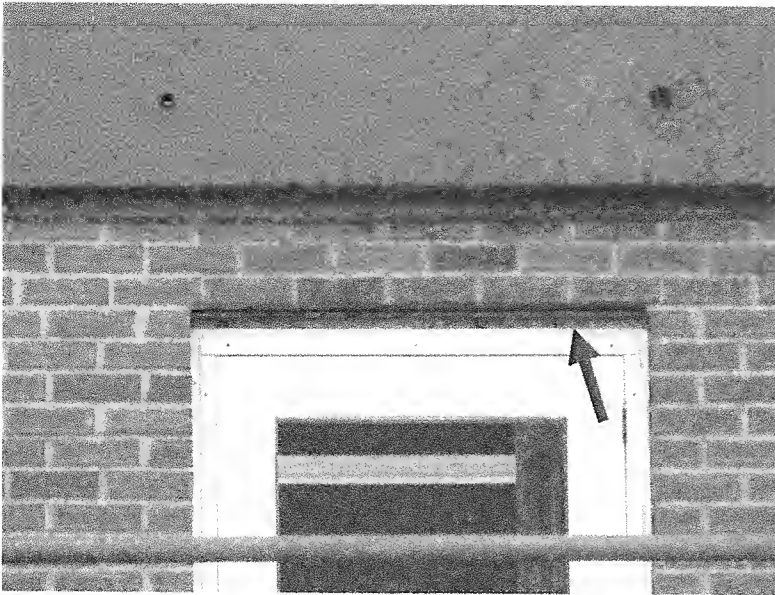
Figure 48. Missing sealant joint above door at north facade

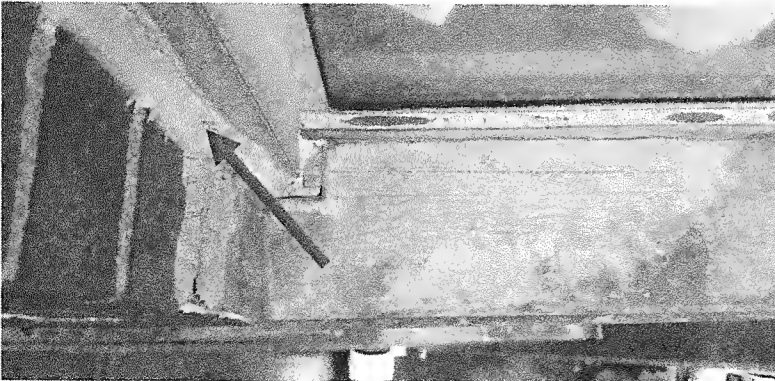
Figure 49. Window perimeter cohesive sealant failure at west facade

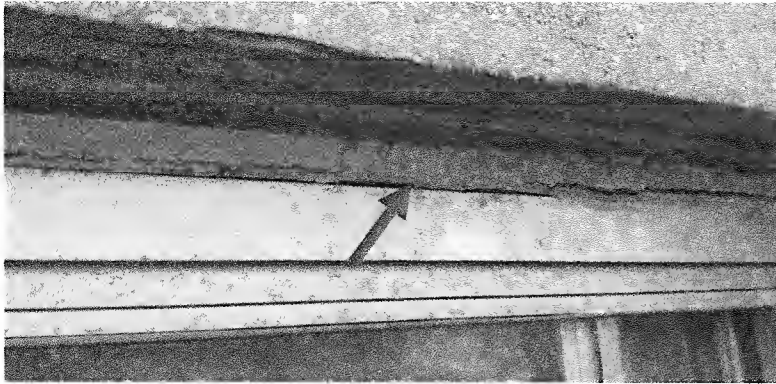
Figure 50. Window perimeter adhesive sealant failure at west facade

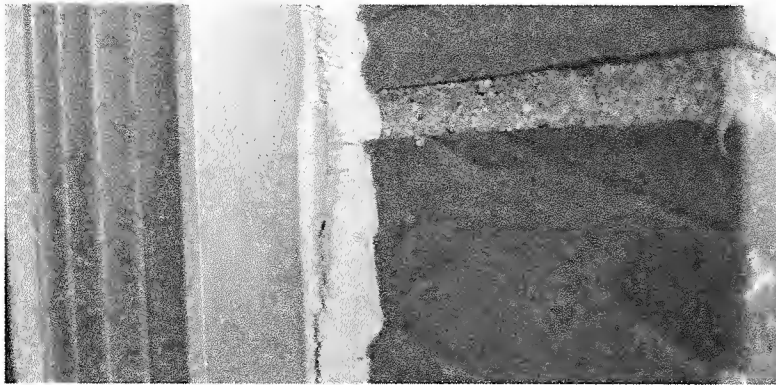
Figure 51. Multiple layers of installed sealant

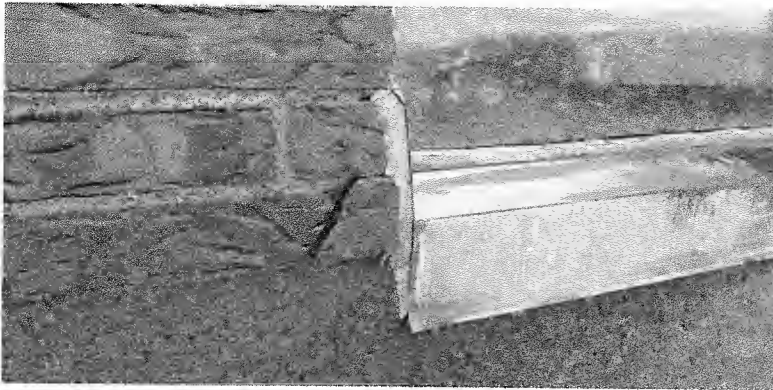
The second test was performed at the sill flashing and adjacent damaged brick veneer (Figure 55). Water was sprayed from slightly below the flashing. Water was observed at the interior at the floor immediately below the sill after approximately five minutes of testing (Figure 56). Parquet flooring was removed to better observe the water infiltration (Figure 57). Water continued to enter at the floor line of Unit 1102 even after the water was shut off.

Figure 55. Location for water testing of sill flashing and brick veneer

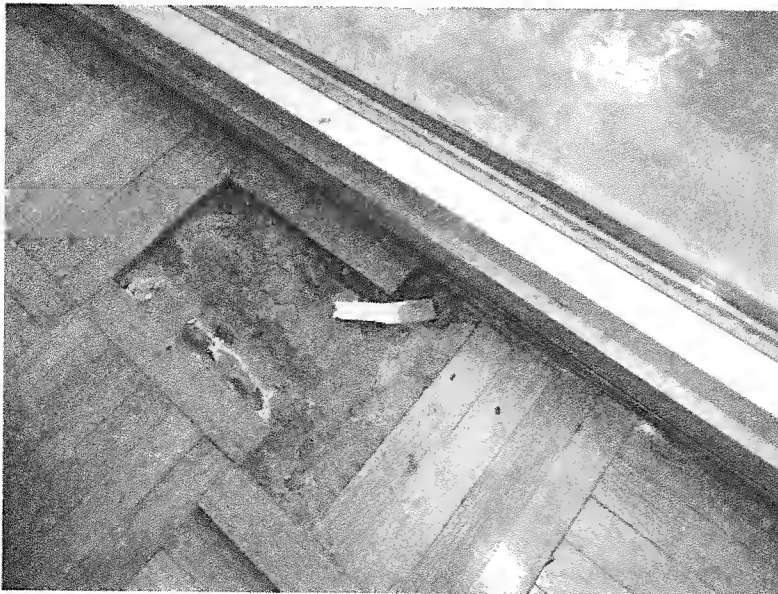
Figure 56. Water infiltration below window sill in bedroom of unit 1102 (indicator paper turns pink upon water contact)

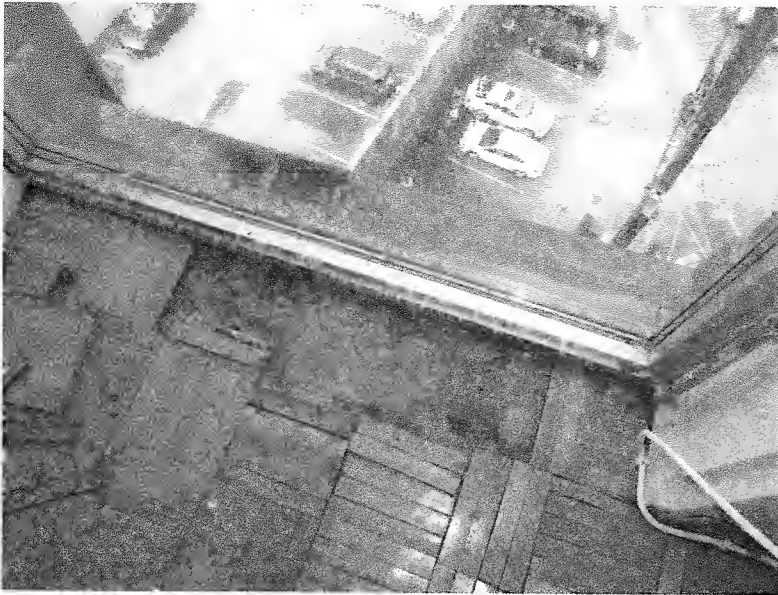
Figure 57. Removal of parquet flooring at leak location in bedroom of unit 1102

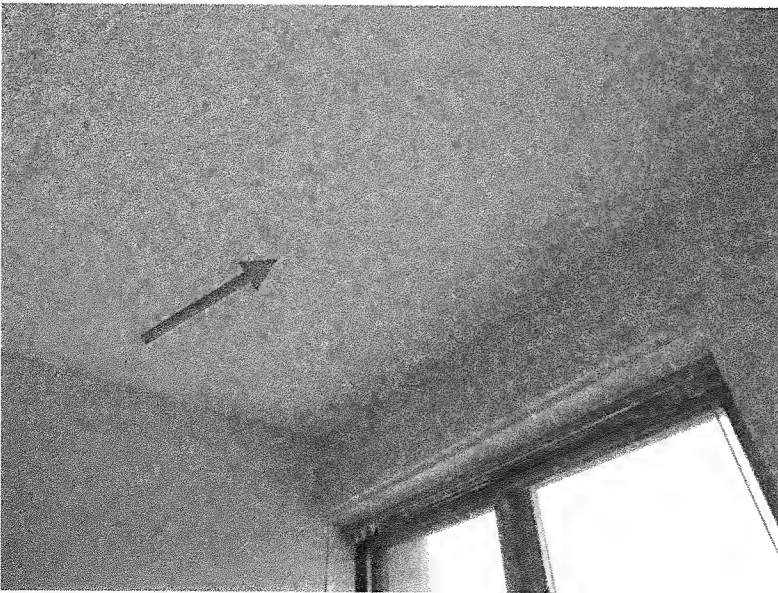
Figure 58. Water droplets on ceiling in bedroom of unit 902
